Date: 6<sup>th</sup> October 2016

# UAE HSV – 2 Swift Incident Report, Bab el Mandeb, 1<sup>st</sup> October 2016

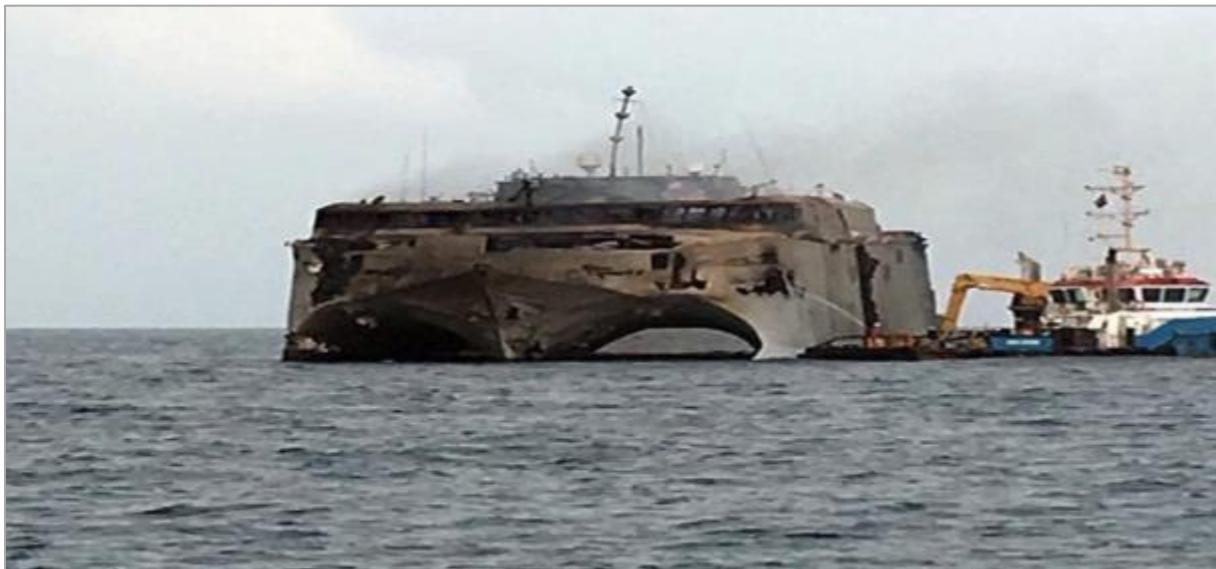
*HSV-2 Swift being recovered following the attack*

The UAE HSV-2 Swift supply vessel transiting from Aden to Al Hodeidah, Yemen on 1 October 2016 was hit by a missile and video released by the Houthi Yemeni rebels suggests that the missile strike set the vessel on fire and badly damaged it. Reports have been received this week that the vessel has been towed from the scene by vessels associated with the Saudi led coalition.

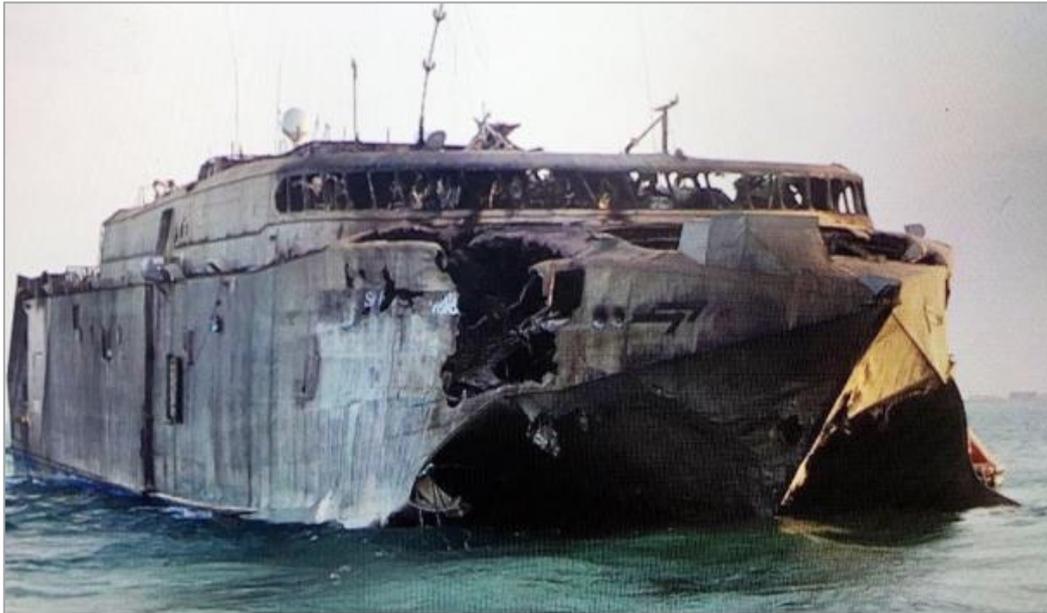
*Image showing the impact damage of the missile on HSV -2's Starboard bow*

If it was a C704 that was used against the HSV-2 (gross tonnage of 5,936) the choice of missile was a good one despite the vessel being slightly bigger than the optimum size for the missile. HSV-2 was aluminium hulled and soft skinned. The weapon would easily penetrate such a hull, and this seems to have been the case on 1 Oct.

There are also unsubstantiated reports that the attack was conducted from a small boat using a shoulder launched rocket. The damage sustained to the vessel is greater than would be expected from such an attack and so far, everything we have seen fits with the assessment that this was a surface to surface missile attack.

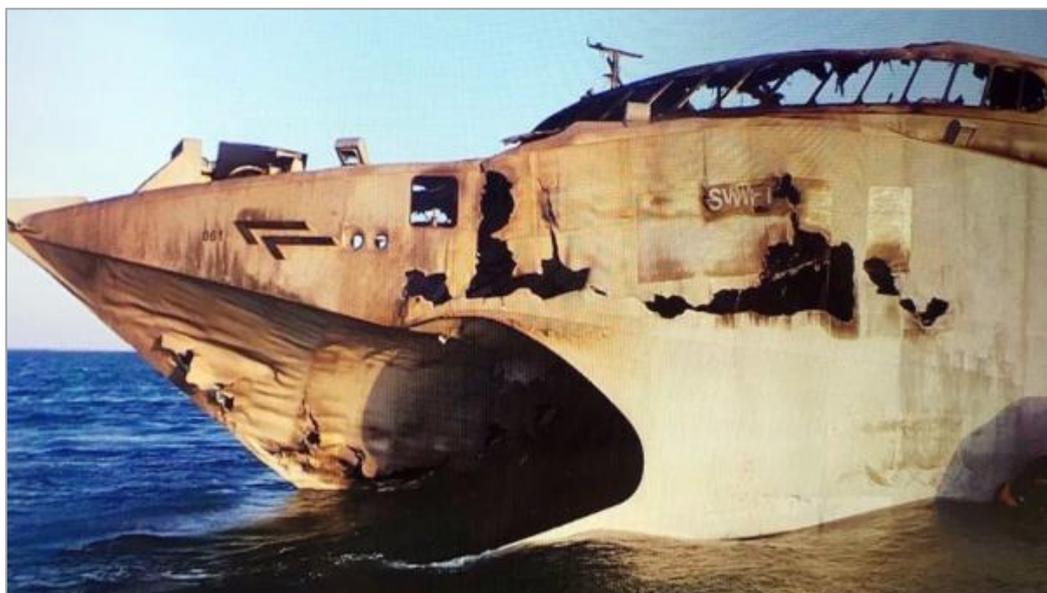
*Image showing the exit blast damage on HSV -2's Port bow*
